Accuracy of GPR based 3D fracture surface geometry interpretation

R. Kiuru¹, P. Kantia², L. Uotinen¹ & M. Janiszewski¹

¹Aalto University School of Engineering, Department of Civil Engineering, Espoo, Finland

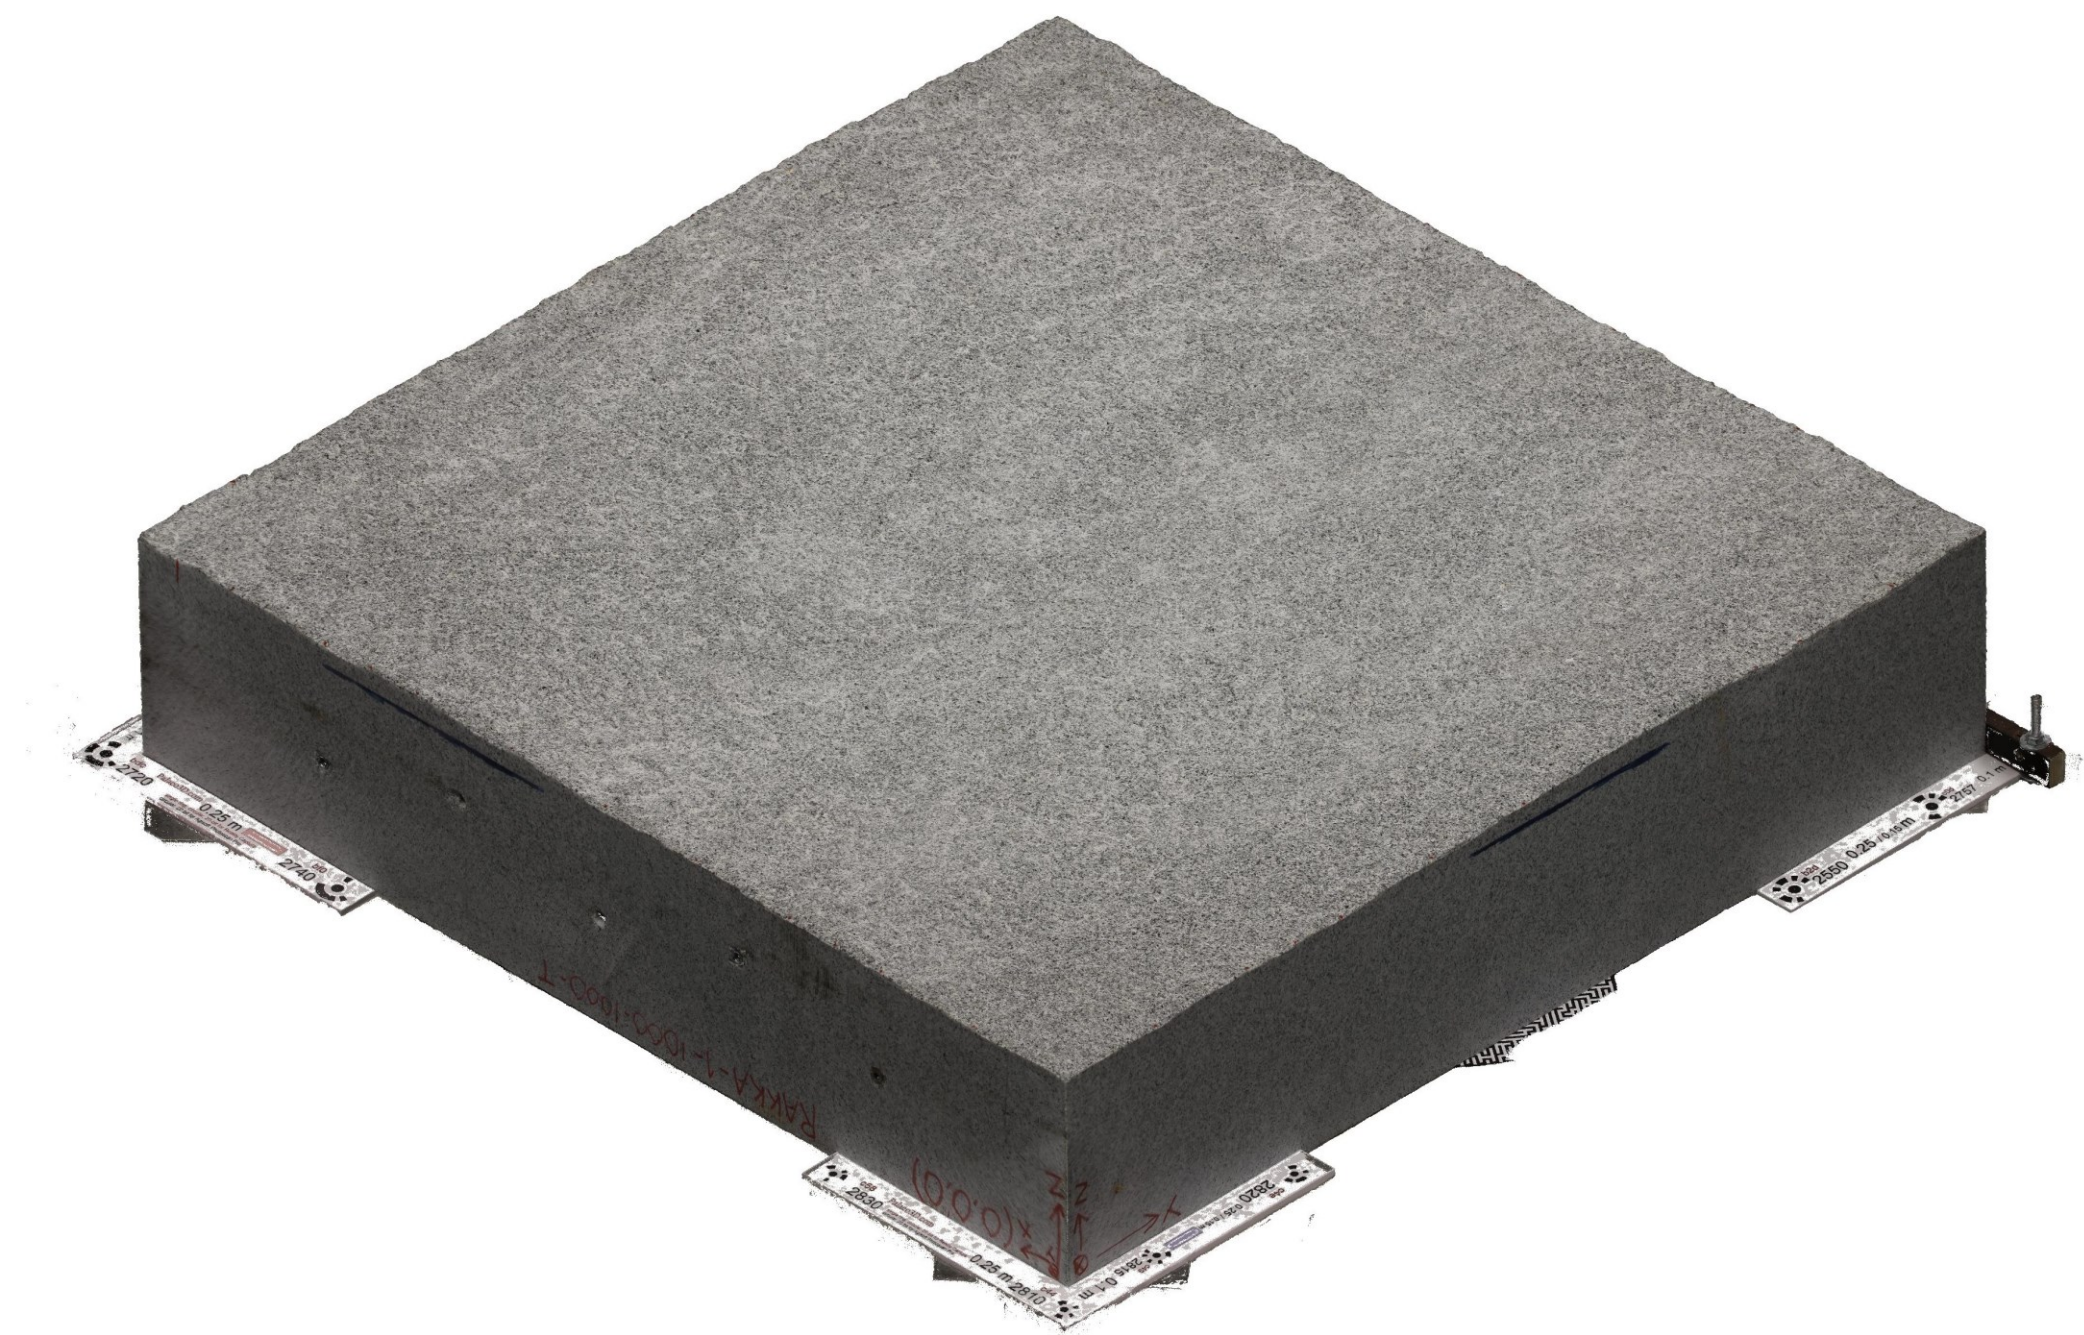
Figure 2. Example of the obtained photogrammetric model for specimen RAKKA-1. Opened fracture surface facing up, topside facing down. Origin of the coordinate system is at the top corner at the bottom of the image. Distance markers can be seen in the corners of the slab.

After the GPR measurements, the top slab was carefully lifted, rotated and placed on a revolving platform for capturing of the true fracture geometry using photogrammetry (Fig. 2). The photographs were taken using Canon 5DS R DSLR camera and Canon 35 mm f/1.4L II USM objective. The camera was held in place using a tripod and the slab was rotated 8.4 degrees between the photographs from dip angles of 30, 45 and 60 degrees resulting in a total of 129 photographs. The photogrammetric modelling and automatic scaling using distance marker were carried out in RealityCapture 1.0.3.9696 software. Further processing and rotation and translation of the point clouds were done using CloudCompare 2.10.1 software. The vertical position of the fracture surface was obtained as two raster X-Y grids with unit dimensions of 1 mm x 1 mm and 0.5 mm x 0.5 mm. Each point in the grid represents the mean height of the points inside the grid square.

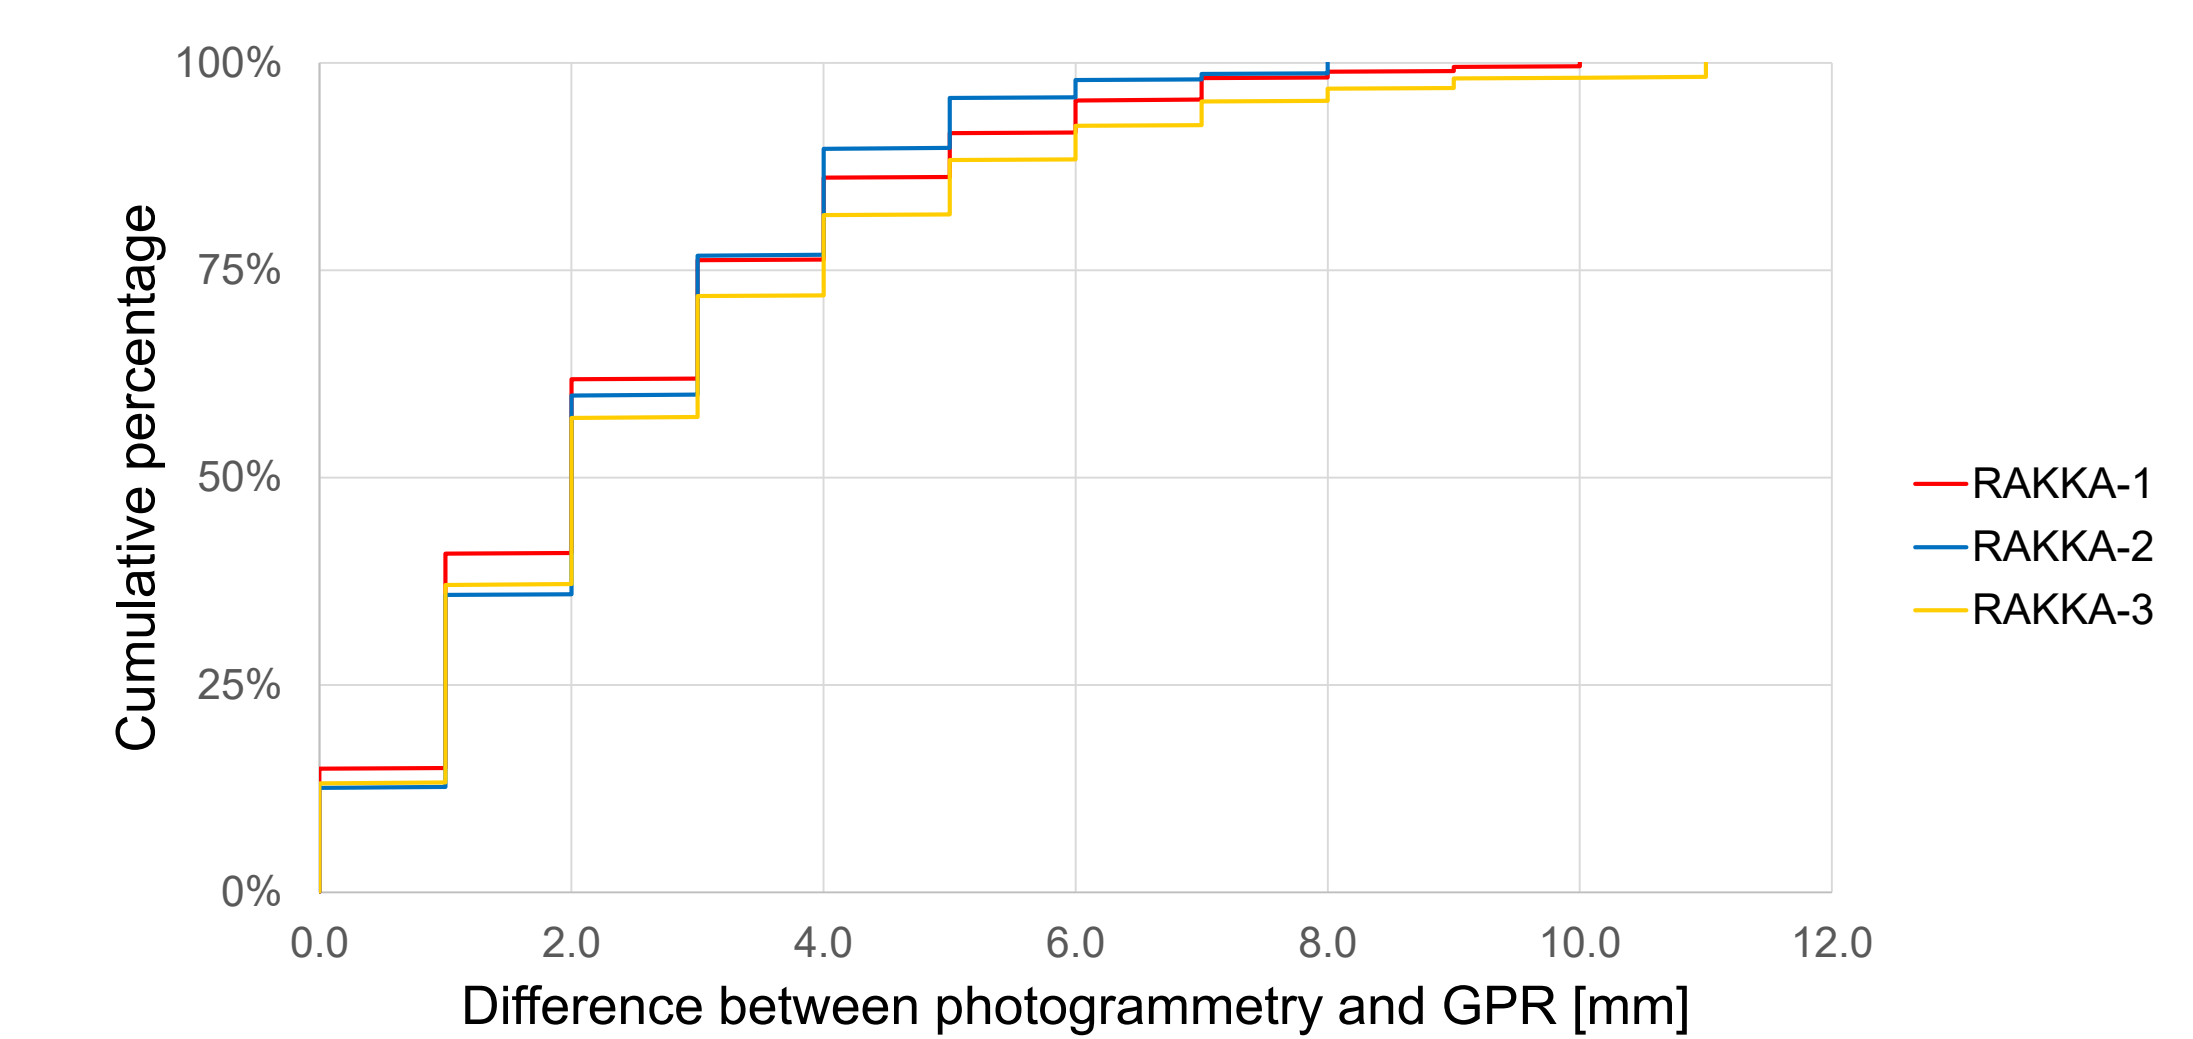
Figure 4. Absolute values of the deviations of the GPR interpretations from the photogrammetrically obtained fracture surfaces for specimens RAKKA-1, RAKKA-2 and RAKKA-3. Data downsampled to 10 mm. Line spacing of GPR 100 mm. Total number of compared points 1193 (RAKKA-1), 1110 (RAKKA-2) and 1117 (RAKKA-3).

Finally, the results from GPR measurements were compared to the photogrammetrically obtained fracture surface geometry to establish the accuracy of the GPR based fracture surface geometry interpretation. This was done by downsampling both datasets to 10 mm in the X and Y directions and comparing the Z values point-by-point. To account for uncertainty in the relative dielectric permittivity values, the GPR measurements were calibrated based on the cumulative distributions of fracture locations. In general, the GPR survey captures the larger scale geometry of the fracture surface to a reasonable degree (Fig. 3). Mean deviations of the GPR interpretations from the photogrammetrically obtained fracture locations were 2.36 mm, 2.33 mm and 2.70 mm with standard deviations of 1.98 mm, 1.70 mm and 2.34 mm for RAKKA-1, RAKKA-2 and RAKKA-3, respectively (Fig. 4). With respect to the mean fracture depths of 191 mm, 205 mm and 187 mm this works out to 1.24 %, 1.14 % and 1.44 % for RAKKA-1, RAKKA-2 and RAKKA-3, respectively.
